**THE CONTRIBUTION OF EO AND GEO-INFORMATION DATA IN THE
ASSESSMENT OF HYDROGEOLOGICAL RISKS IN THE LAKE NYOS
REGION, WESTERN CAMEROON**

Paper published in TIGER PROJECT/UNESCO monthly newsletter of November 2008

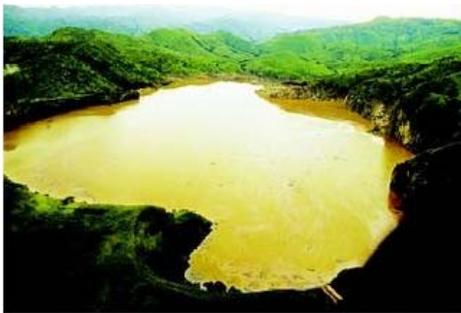
Photo 1: Lake after eruption

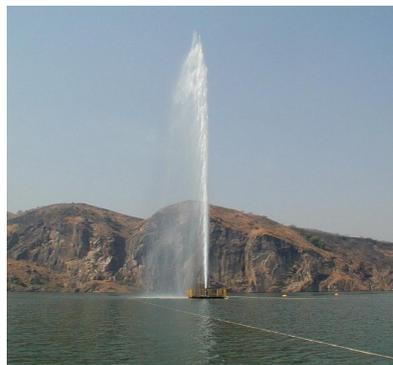
Photo 3: Degasification

For the villagers and many others at the time, this situation could have been the result of a curse from the gods of the lake. But the truth lies in the quantity of CO₂ that was released at once from the bottom of this crater. Faced therefore with this situation, the government evacuated the site and survivors were resettled in a nearby village called Bwabwa. The lake is also being degassed in order to reduce the amount of pressure at its bottom.
